**Smoky Canyon Mine  
Non-Time-Critical Removal Action (NTCRA) – 2015 Activities  
Pole Canyon Overburden Disposal Area**

**Weekly Construction Report**

Prepared by: Formation Environmental (on behalf of the J.R. Simplot Company)

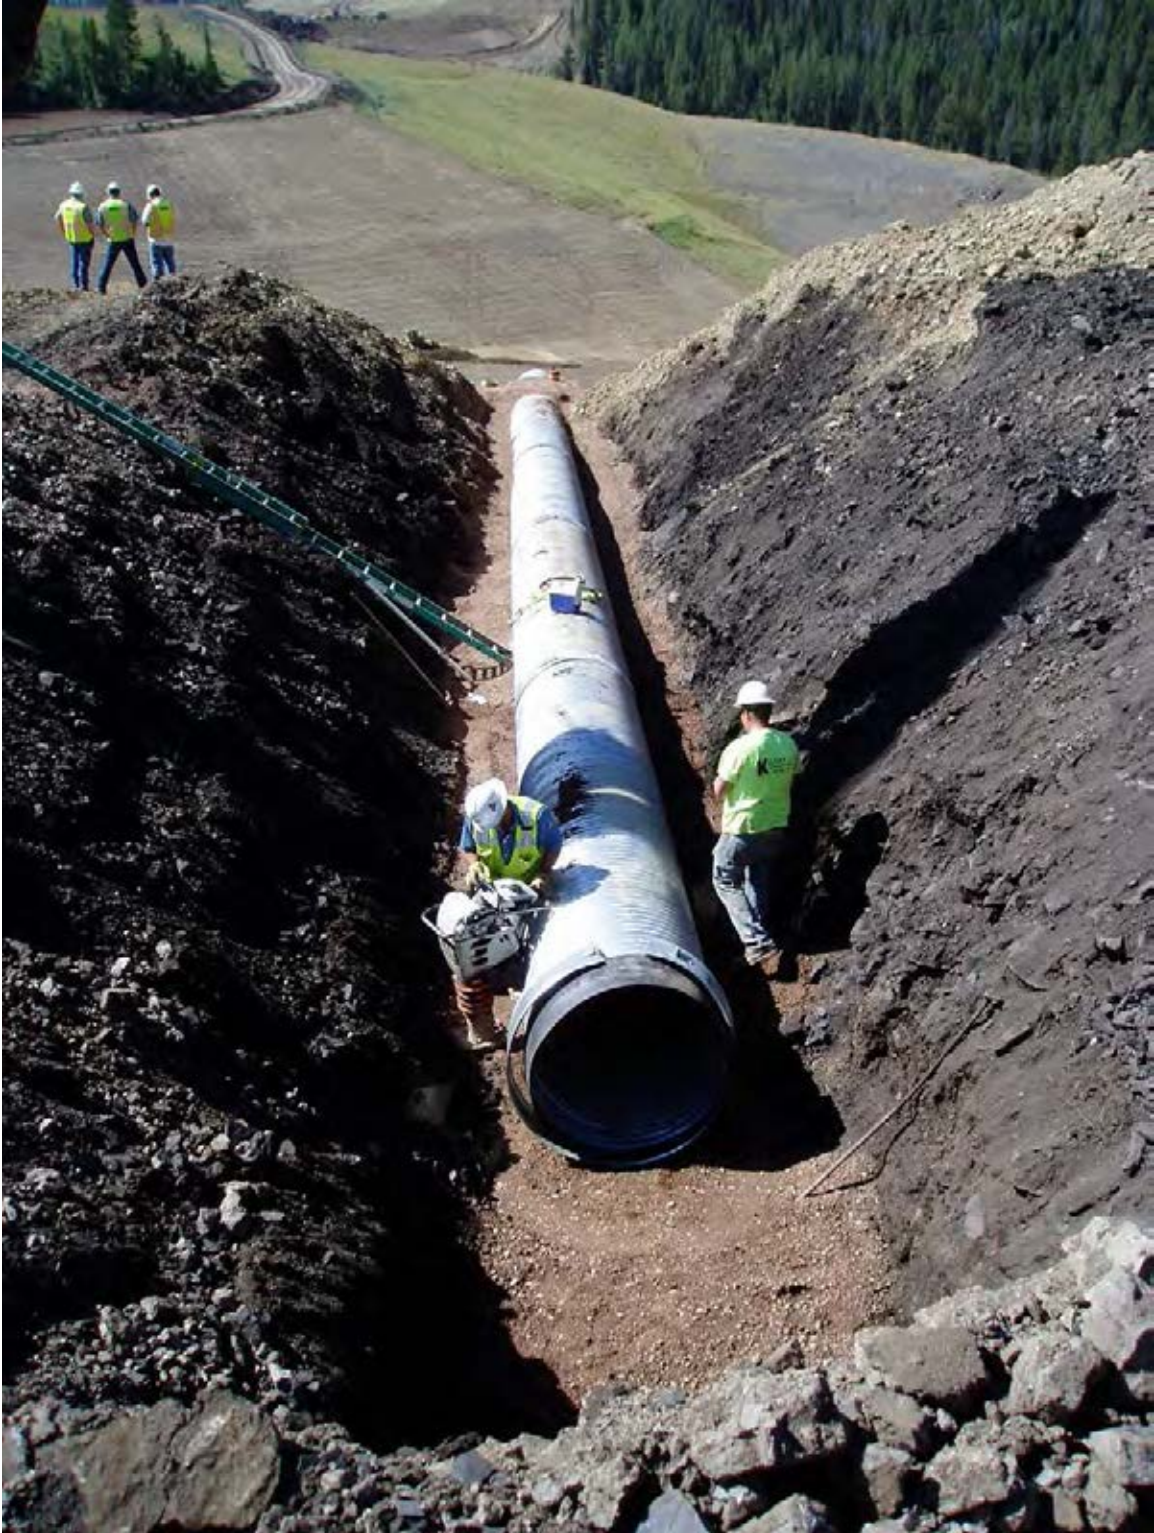
Photograph 3a: Looking west-southwest along 42-inch dia. CMP as worker compact pipe bedding material. Due to the coarse material used to construct road, the pipe bedding was placed 18-inches above the CMP to protect pipe from large gravel point loads.

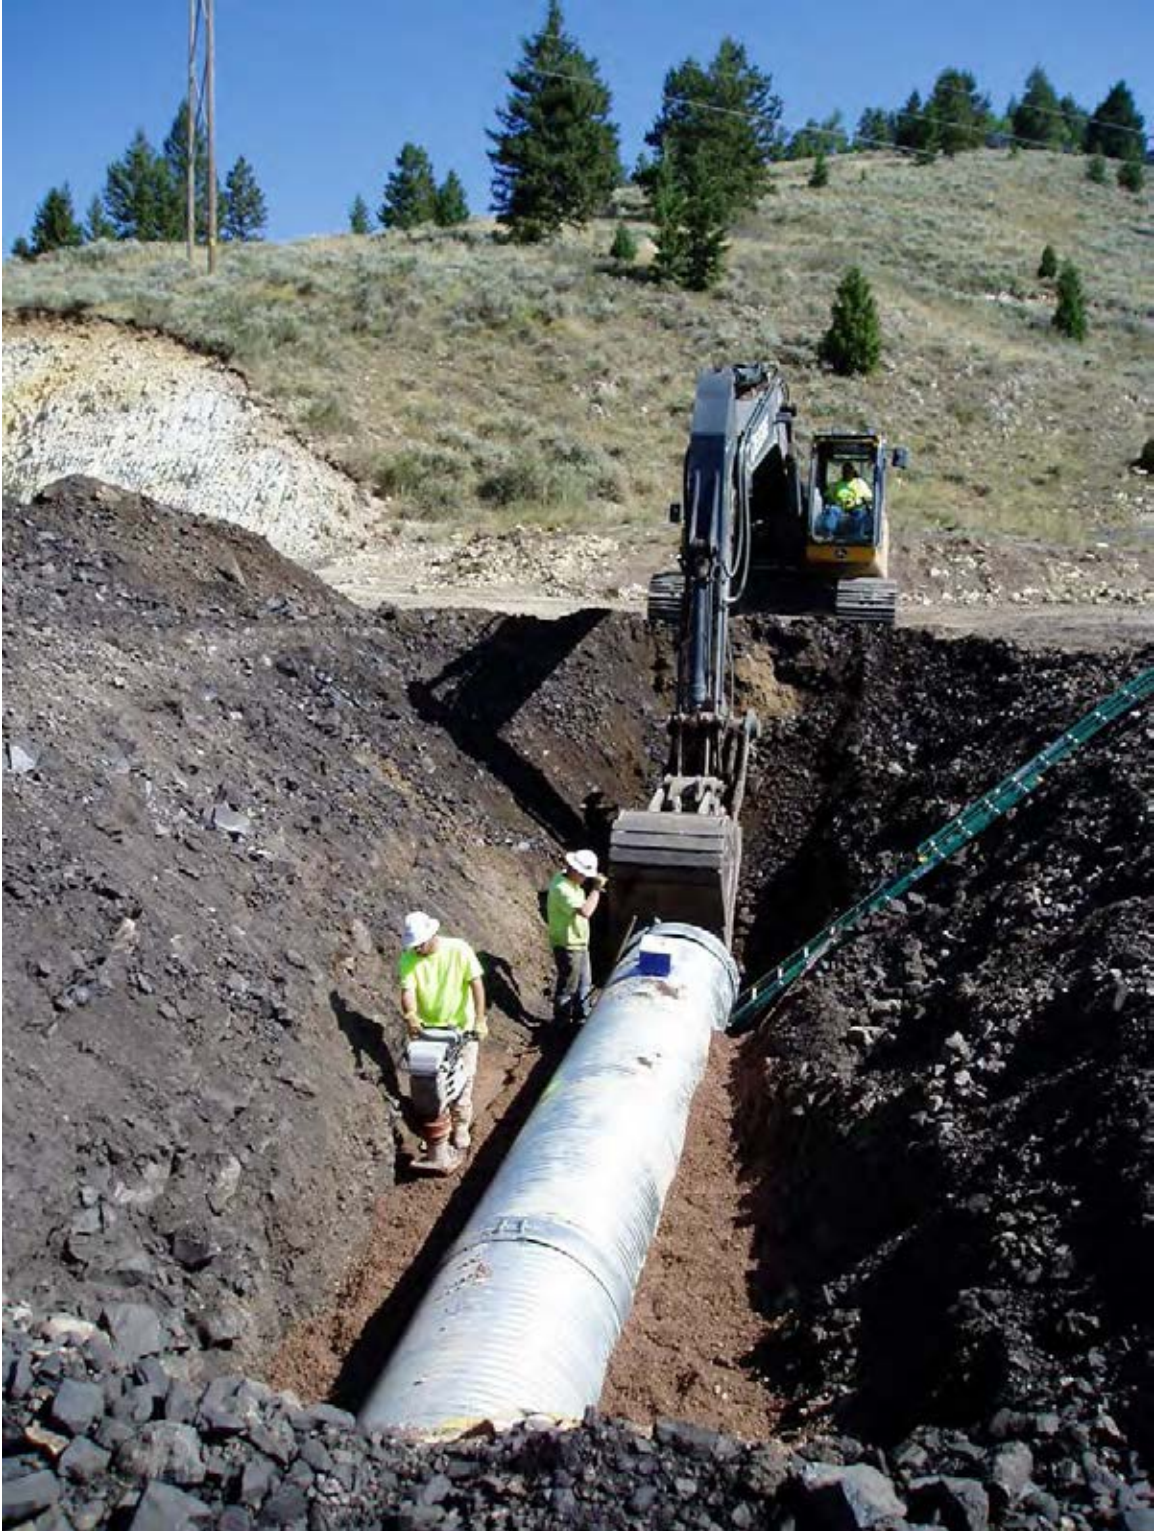
Photograph 3b: Looking northeast along 42-inch dia. CMP in trench excavated across mine haul road. Workers are compacting pipe bedding material with percussion type tamping compactor.

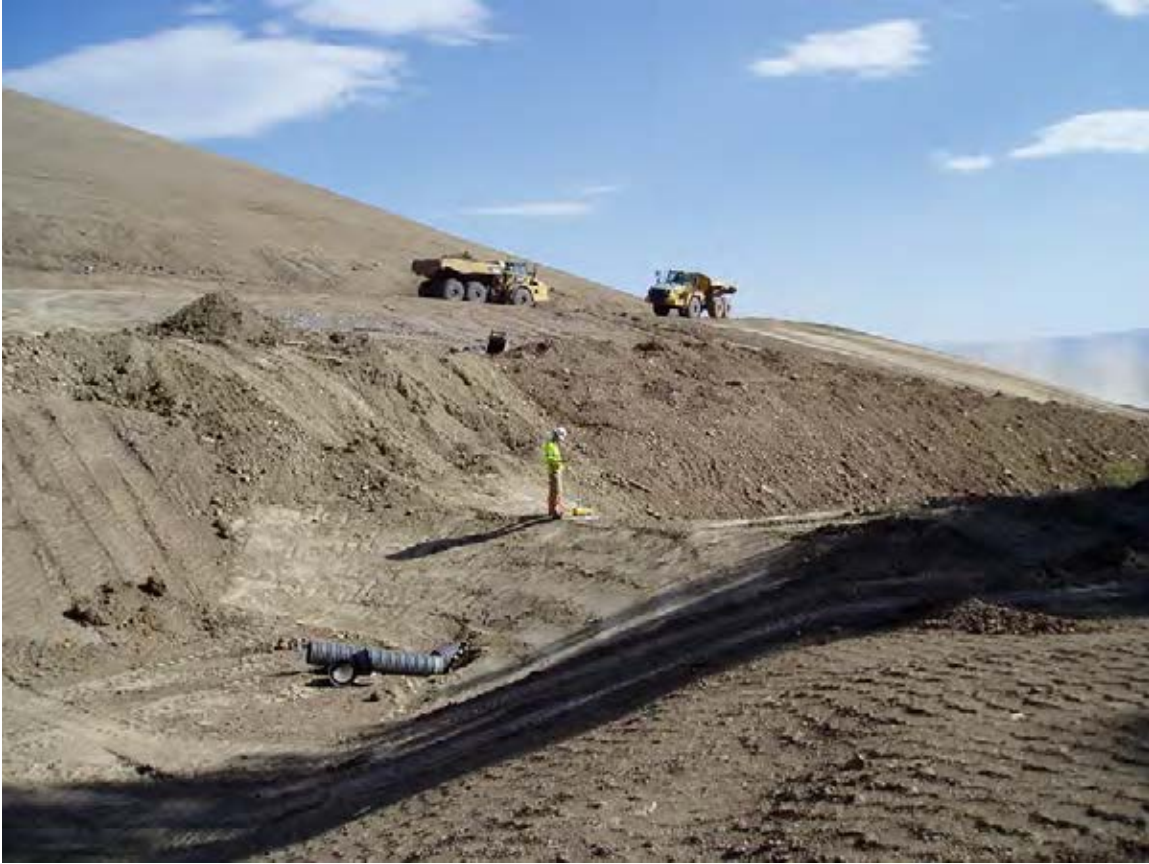
Photograph 6: Looking northeast towards South Central Sedimentation Basin east embankment. Engineering technician performing field density test with nuclear densometer for CQA documentation. Note flow through pipe at base of embankment with 90° elbow yet to be installed.

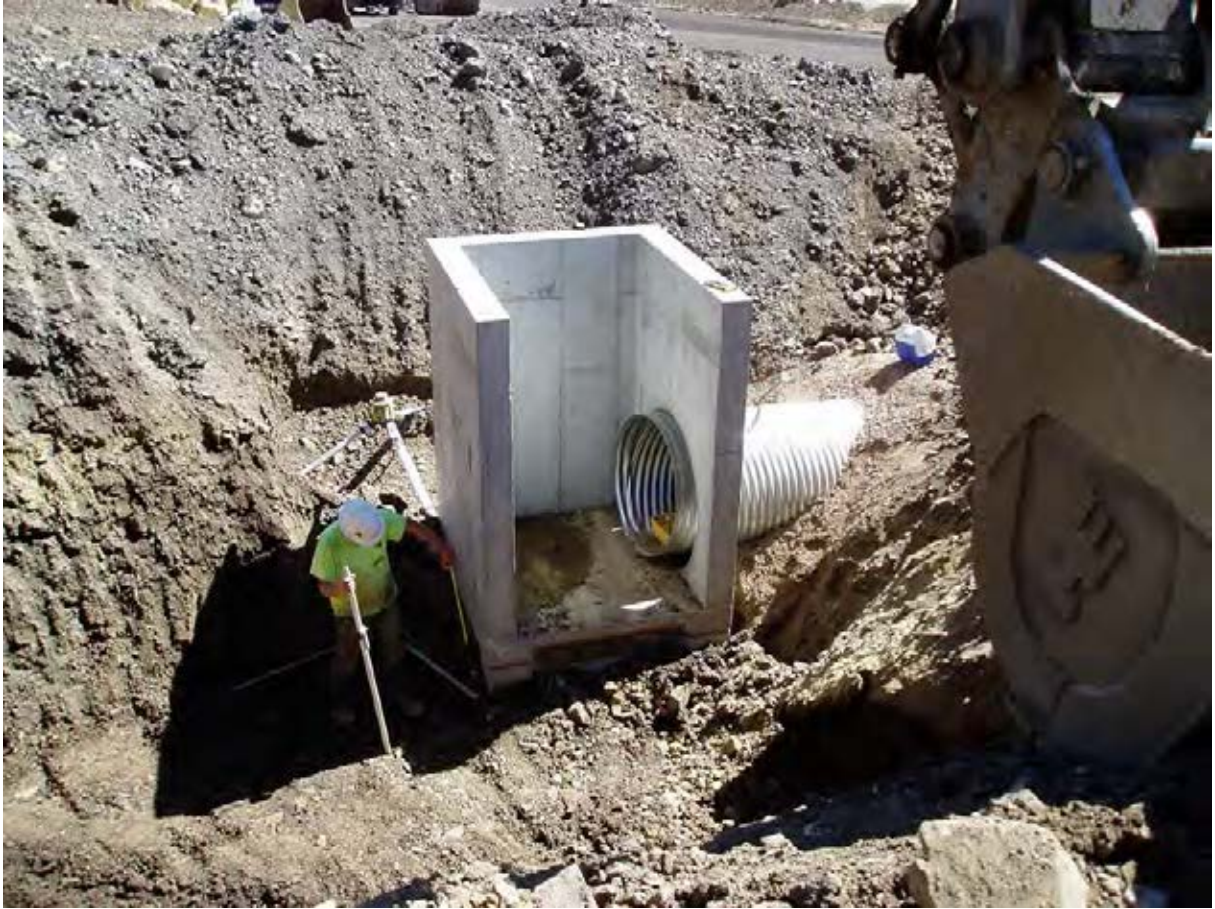
Photograph 3: Looking south at intake structure for 42 inch dia. CMP. Worker is in the process of preparing (compacting and leveling) subgrade for left wing wall.

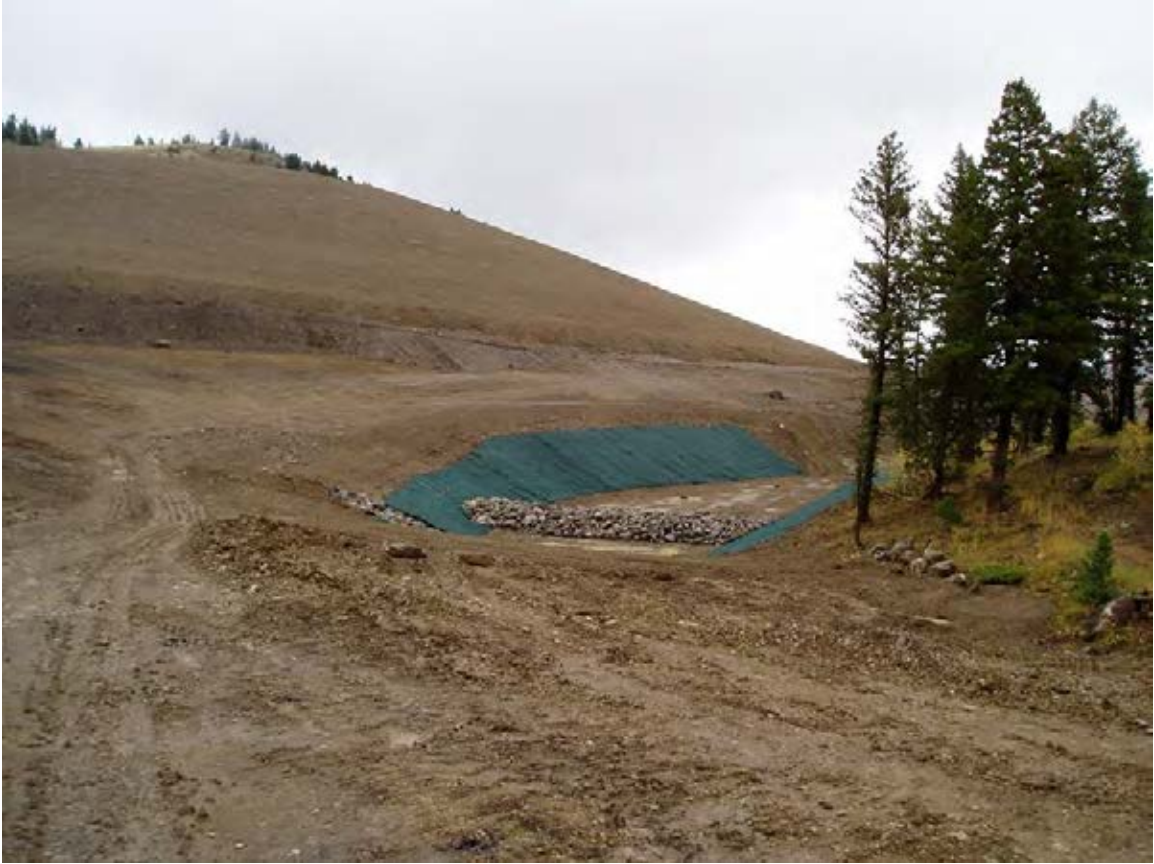
Photograph 1: Looking north east at South Central Sedimentation Basin. Note flow through rock filtration berm, TRM lining on basin side slopes and rip rap for inflow chute in lower left of photograph.

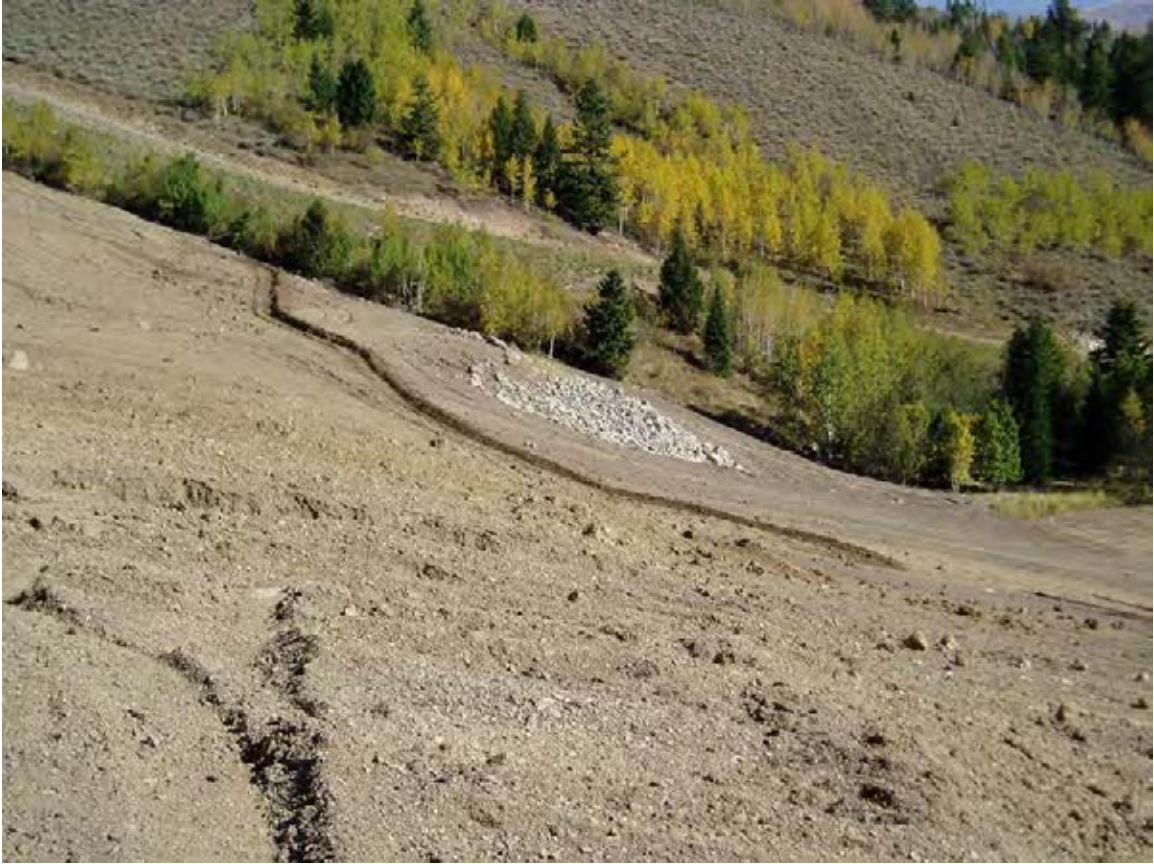
Photograph 1: Looking north east at the lower portion of ES-R2-N and rock buttress. Contractor excavated temporary run-off control ditch to divert water back towards the south and East Sedimentation Basin as a precautionary measure (BMP) in the event a storm were to occur prior to completion of permanent erosion controls are in place.

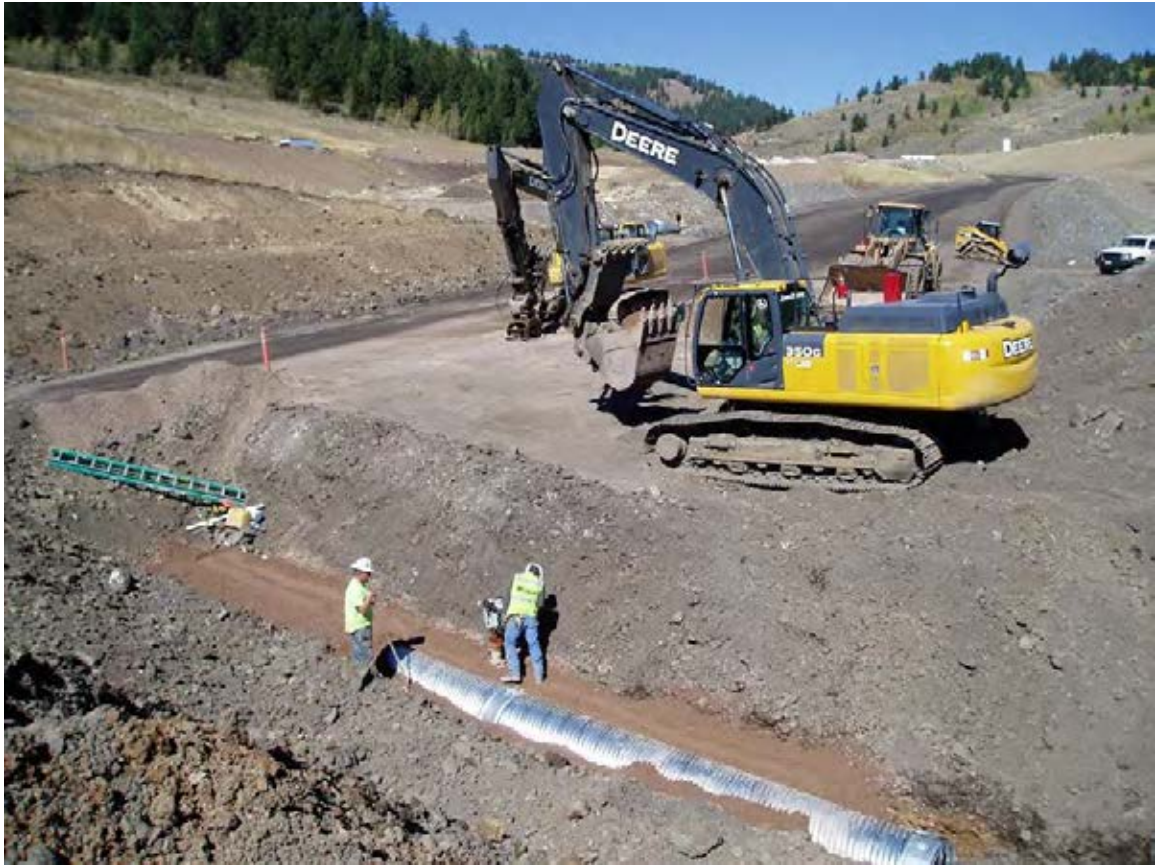
Photograph 4a: Looking northwest at workers compacting pipe bedding material adjacent to and above 36-inch dia. CMP (South Culvert) that crosses mine haul road at the south end of the project area.

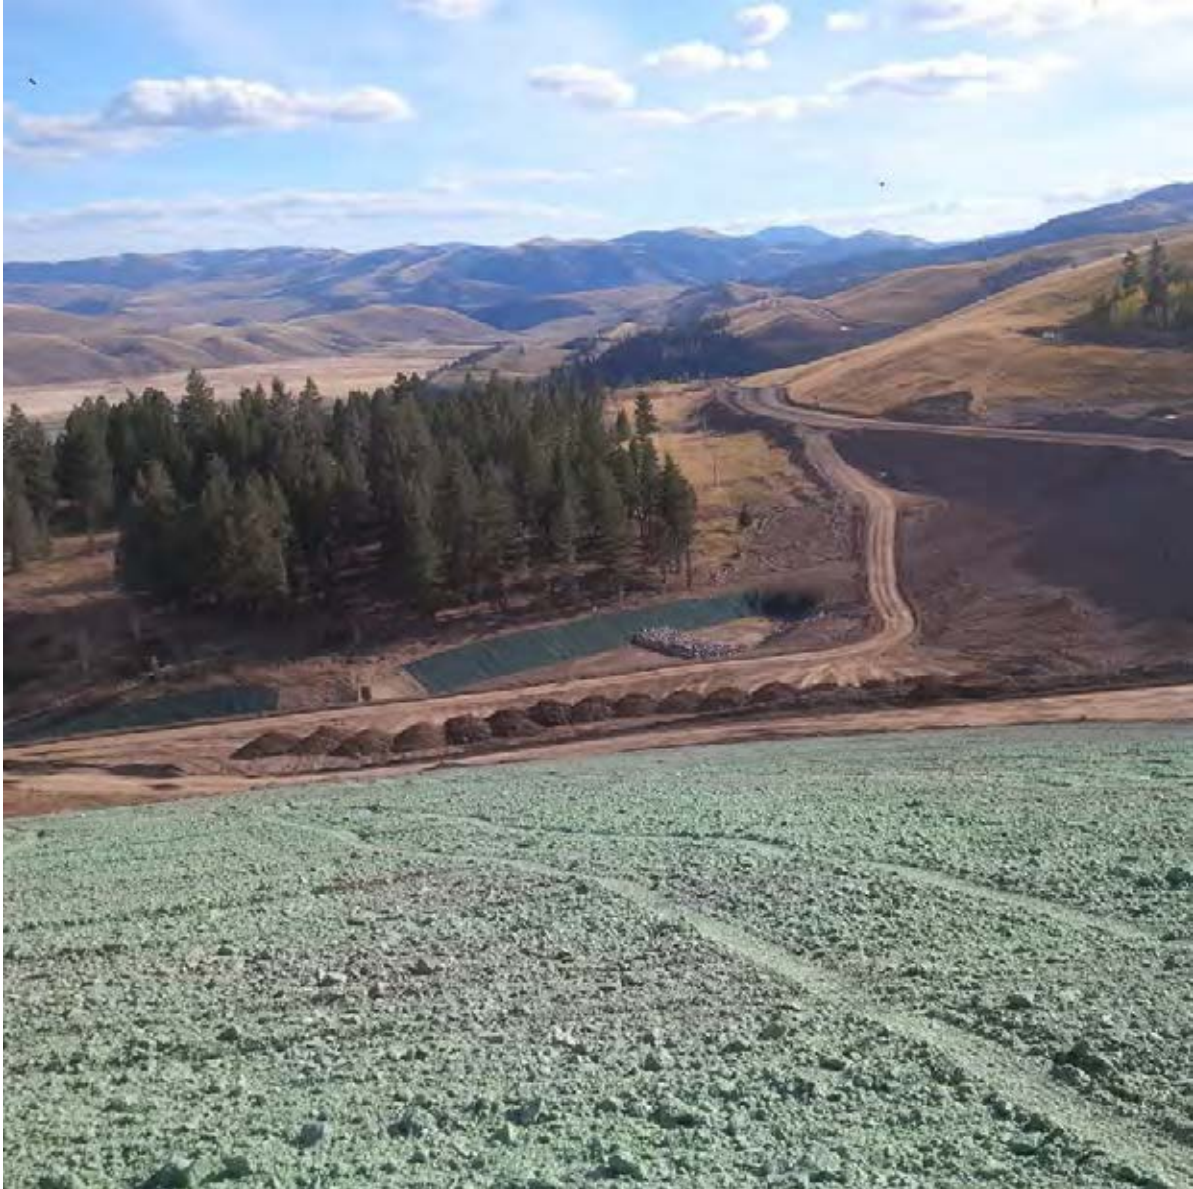
Photograph 1: Hydroseeded South East-Side Slope above South-Central Sedimentation Basin showing Dinwoody piles to be spread.

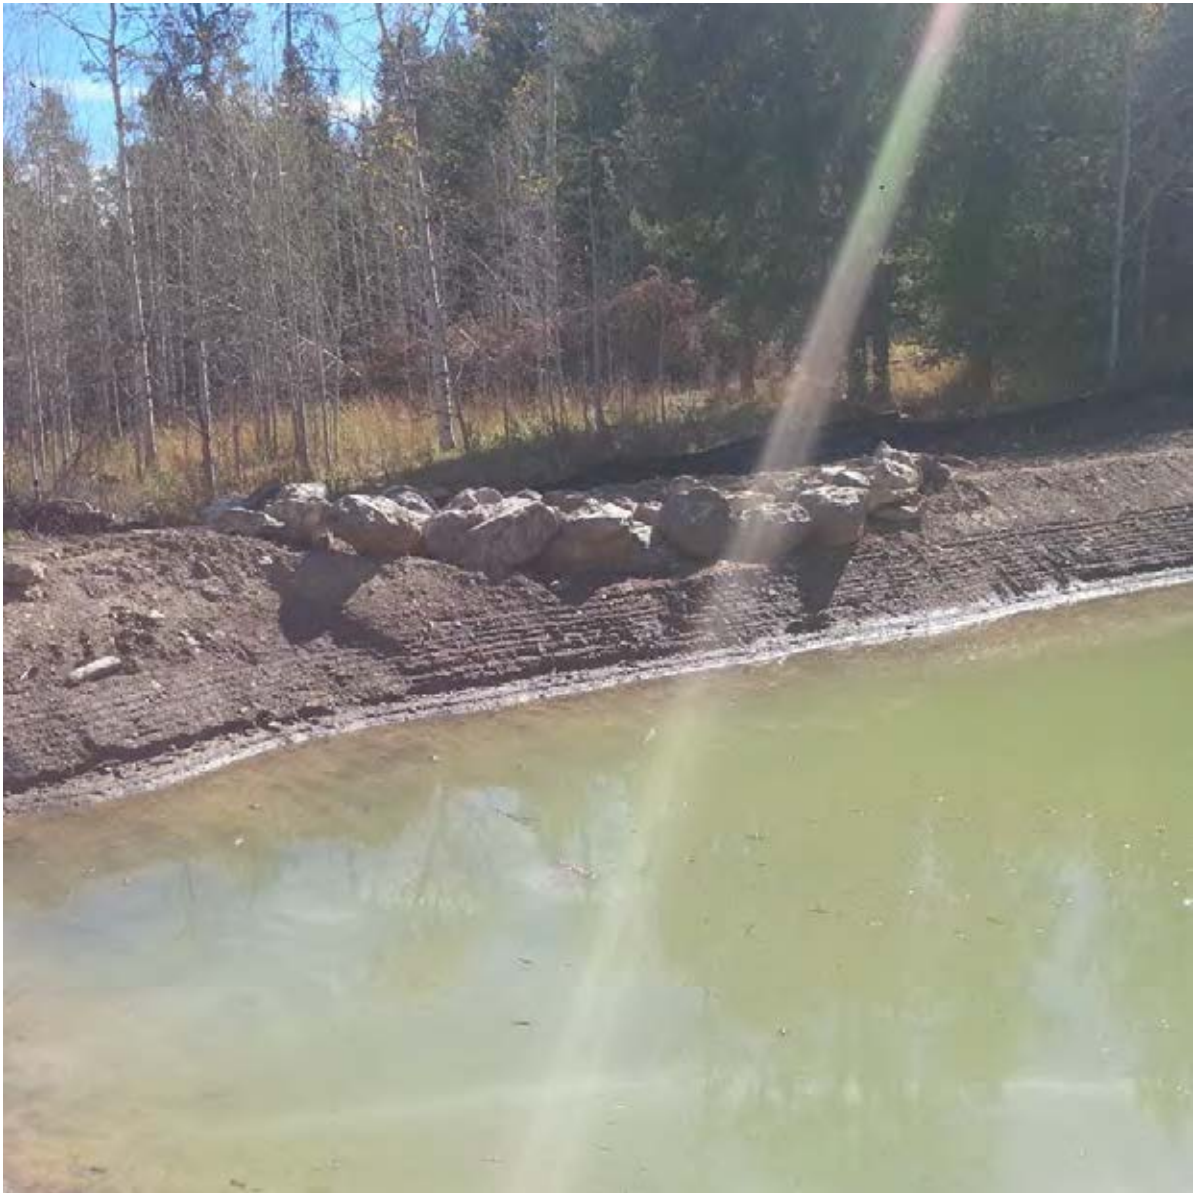
Photograph 2: East Sedimentation Basin with rough spillway requiring completion by removal of oversized rip rap and installation of concrete cutoff wall at control section.

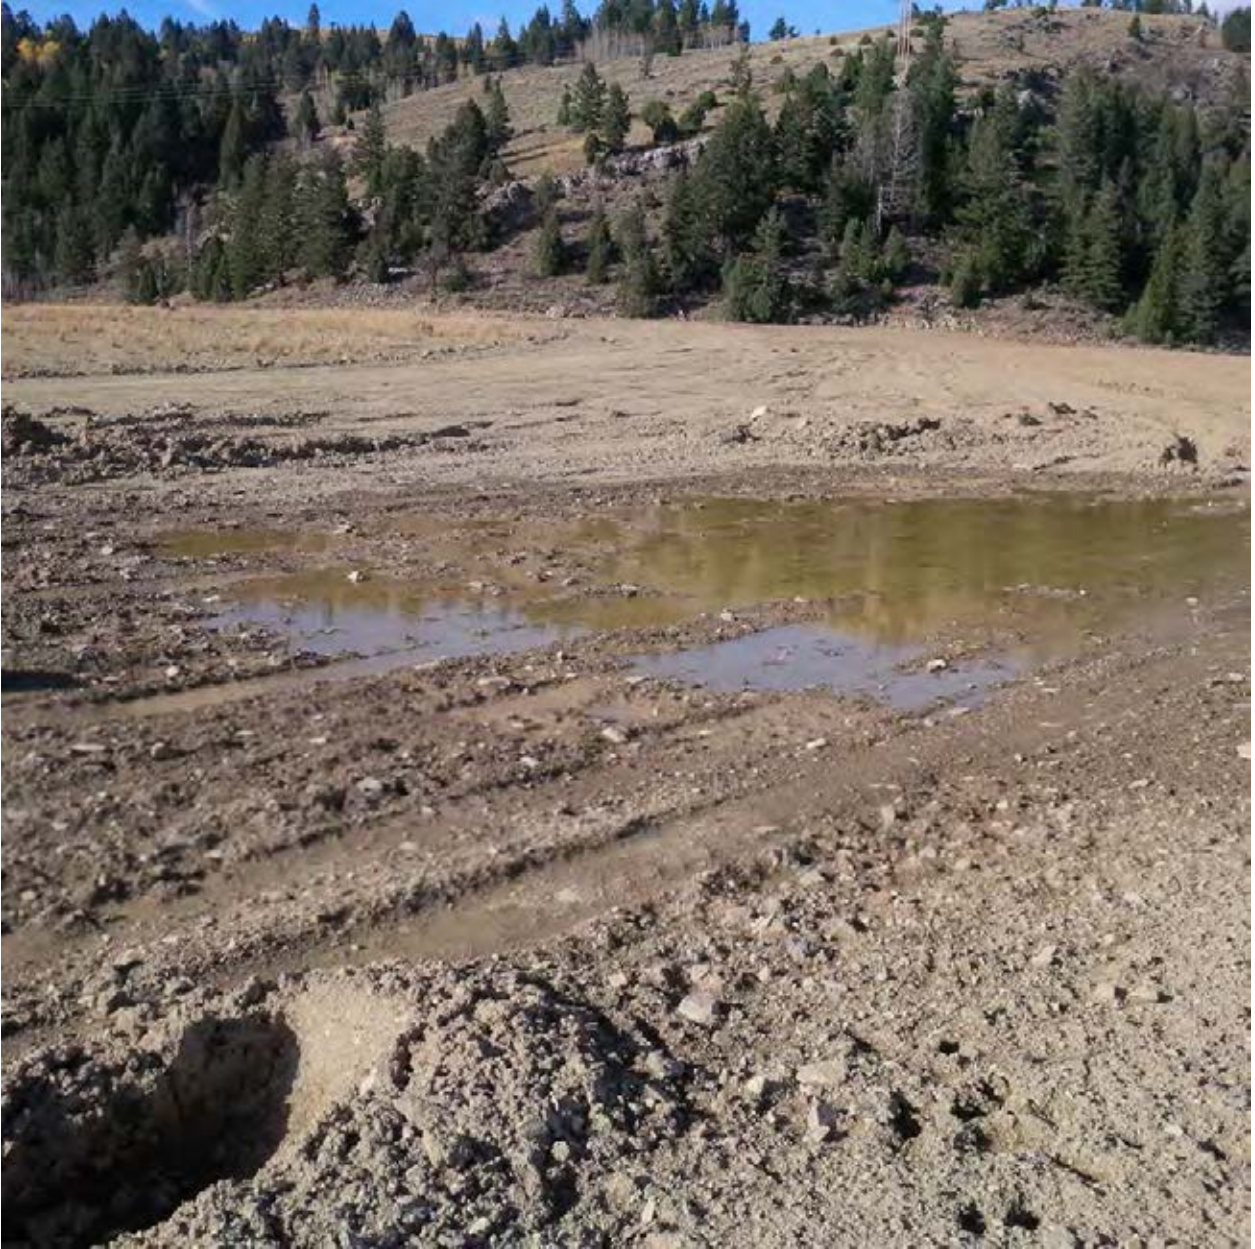
Photograph 4: Top east side of ODA requiring final grading to eliminate ponds; pad for Blast Compound and final contractor staging area to left (not shown).

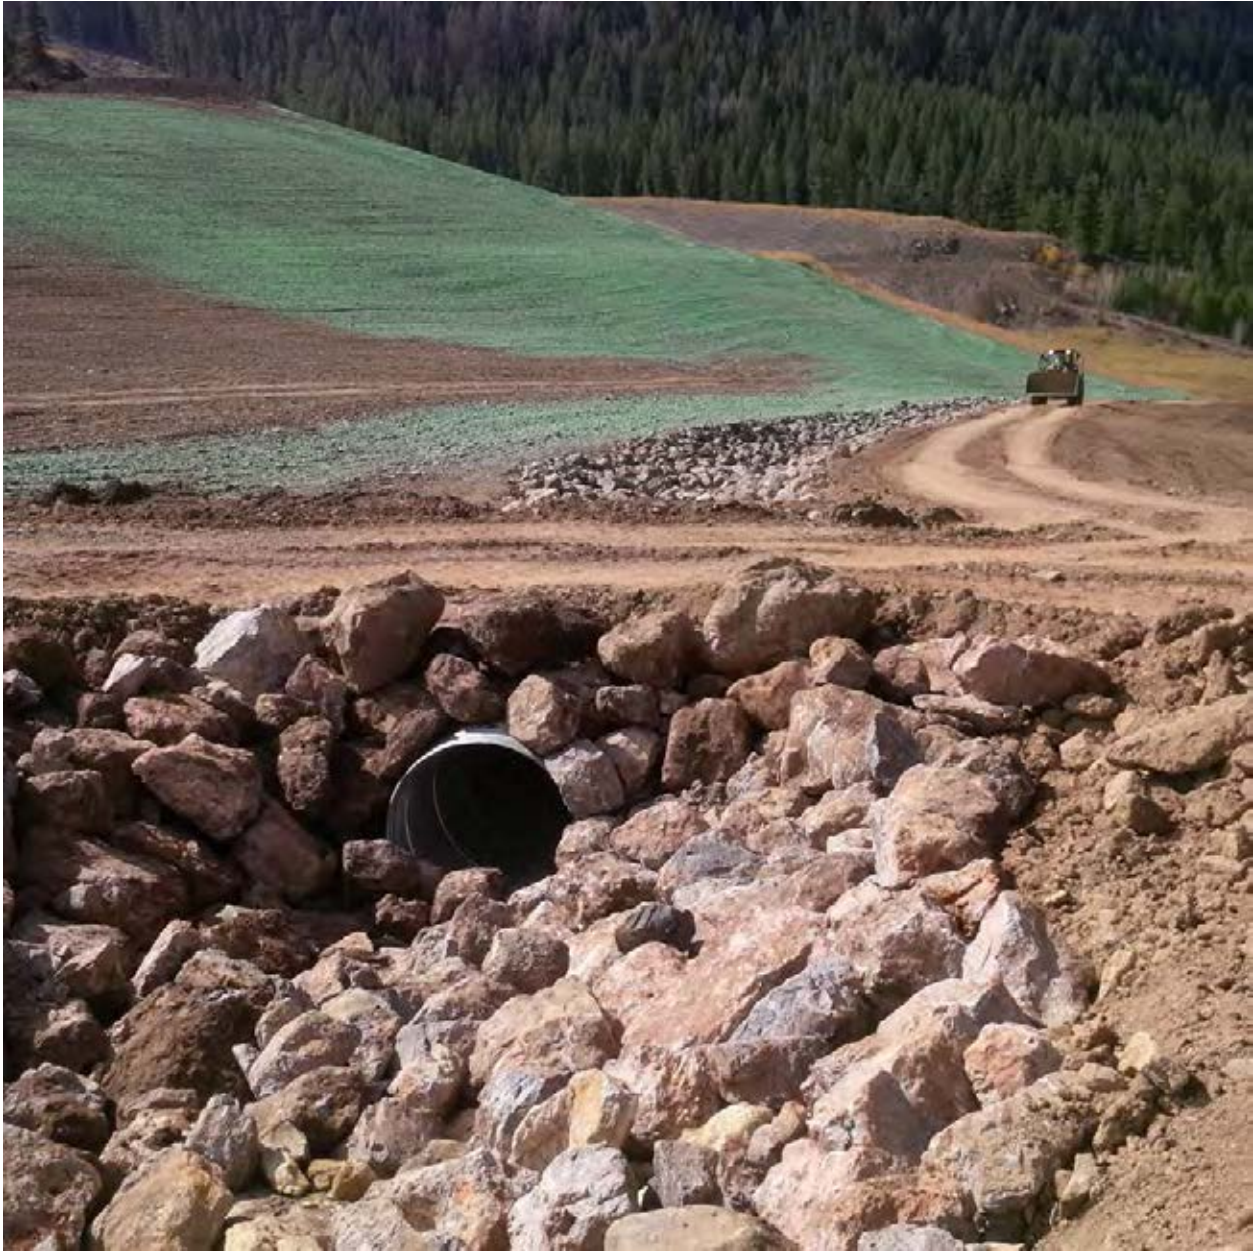
Photograph 6b: 48-Inch CMP in West-Side Runoff Ditch (requires inlet section and additional cover at road crossing).

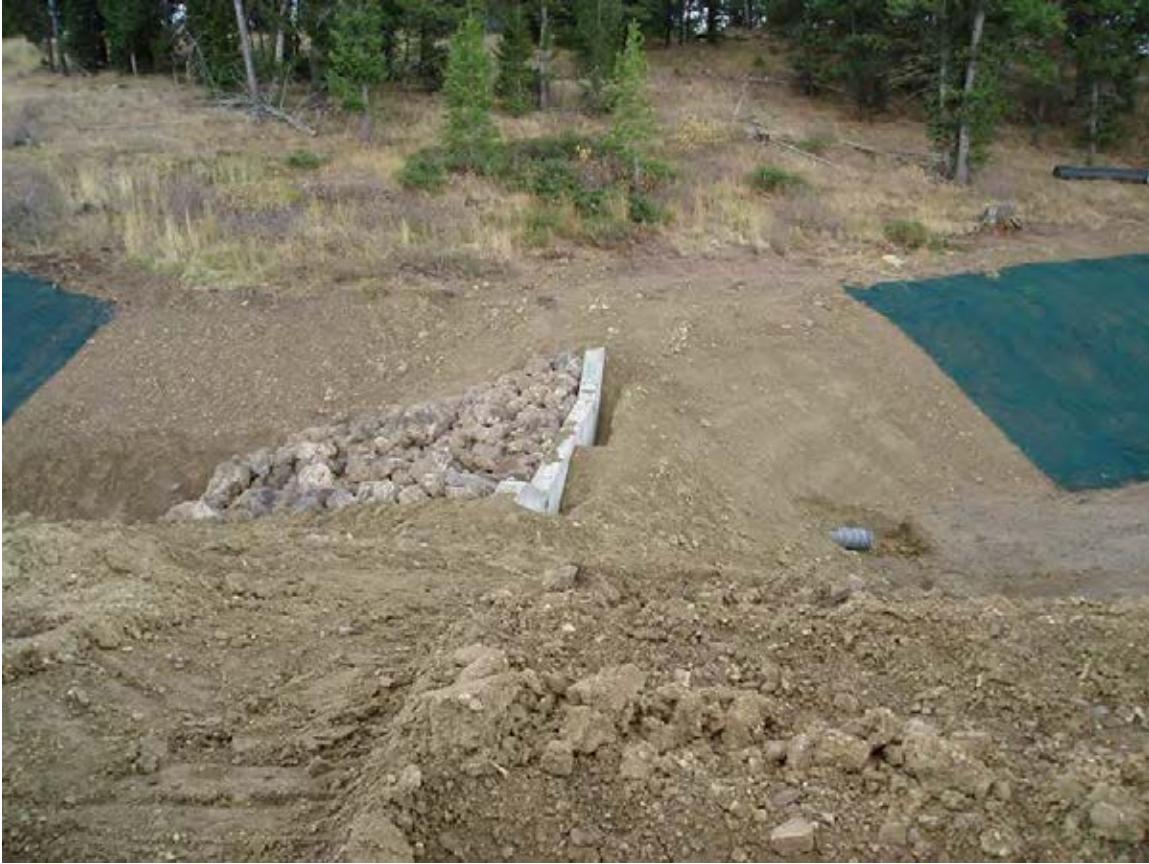
Photograph 1: Looking south at concrete cutoff wall installed in embankment spillway outflow of South Central Sedimentation Basin with riprap in-place on downstream side of wall. Note corrugated 12-inch dia. HDPE low flow outlet pipe on upstream side requiring 90 degree elbow riser and grated inlet cover to be installed.

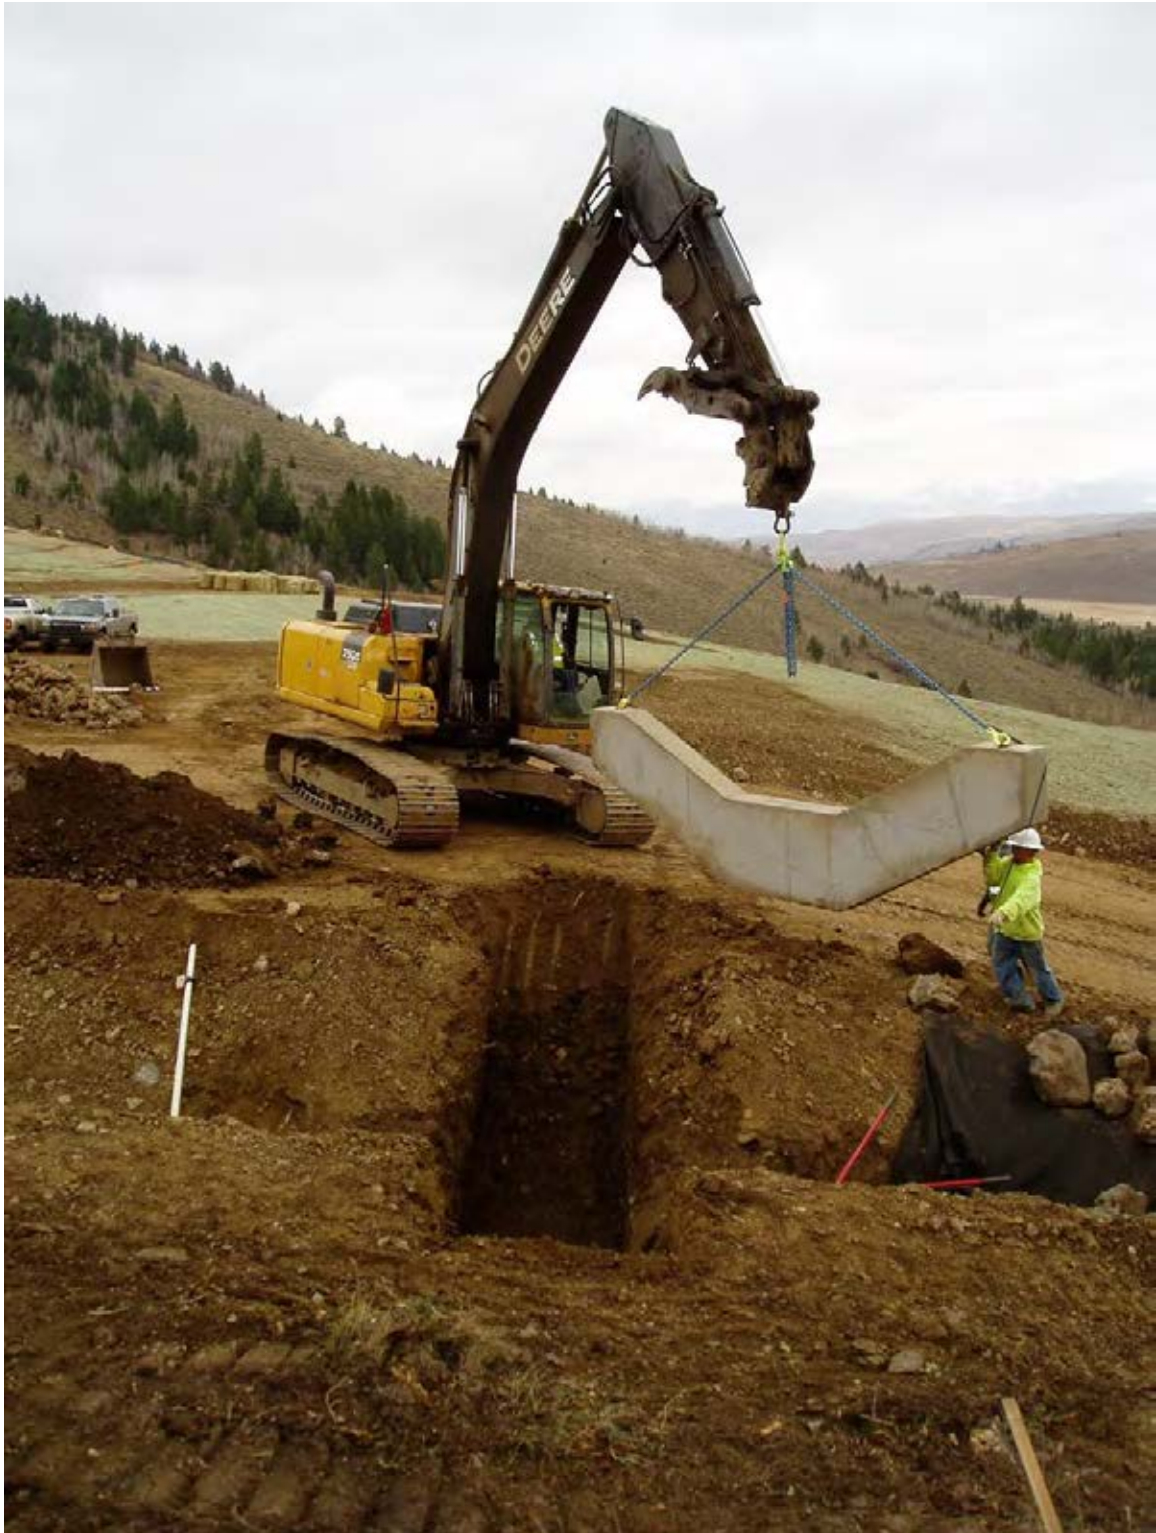
Photograph 3a: Looking north as pre-cast concrete cutoff wall is being placed in excavation at transition of the South Central Runoff Control Ditch transition from trapezoidal section to V-ditch section at chute.

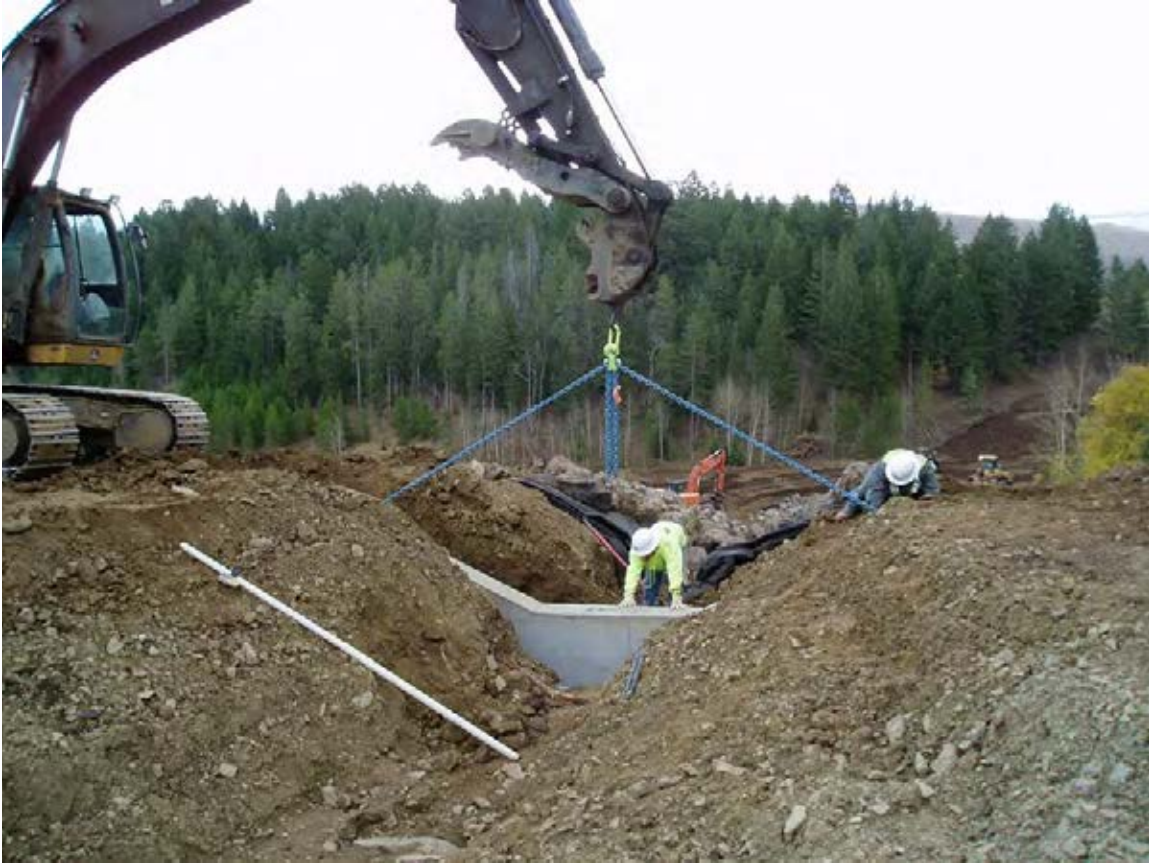
Photograph 3b: Looking southwest and upstream as pre-cast concrete cutoff wall is being placed in excavation at transition of the South Central Runoff Control Ditch transition from trapezoidal section to V-ditch section at chute.

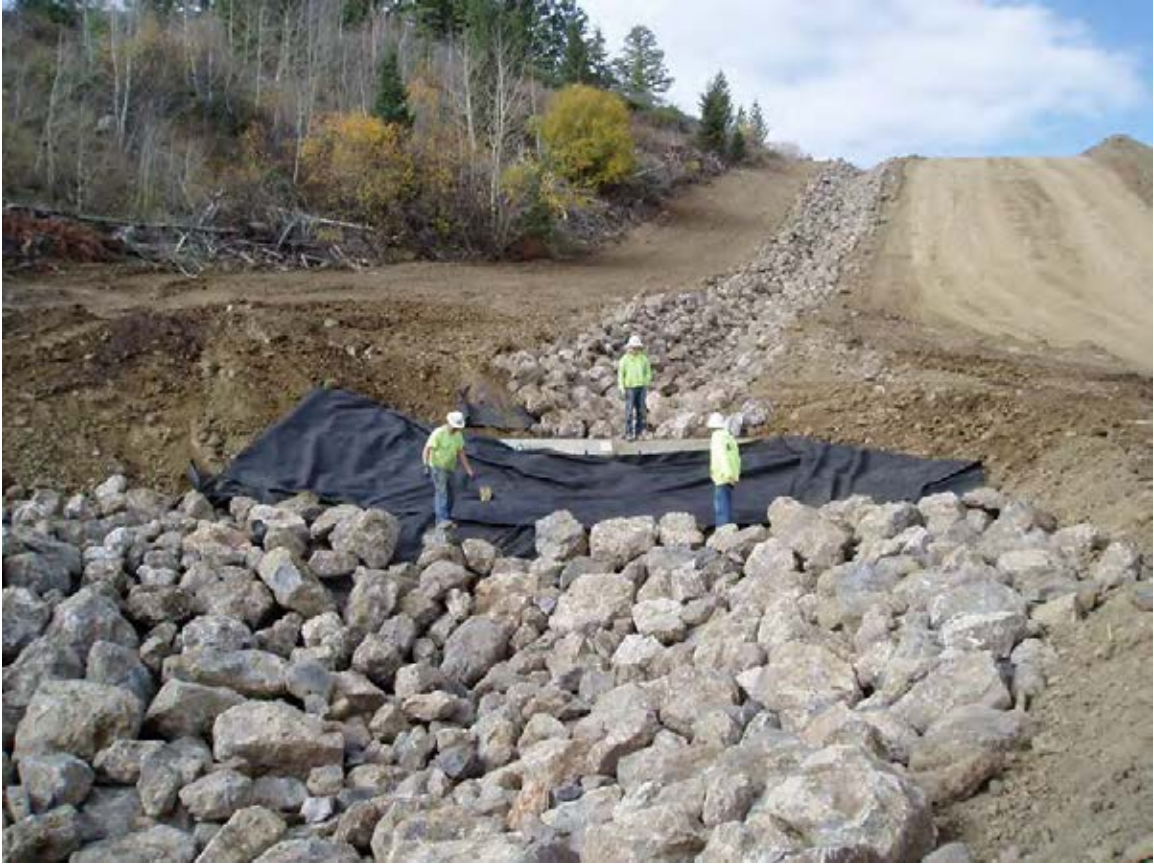
- Place geofabric and riprap adjacent to cutoff wall (Photograph 4).
  - Grout riprap.
- Saddle Infiltration Basin
  - Place and compact fill material (chert from Windy Gap) for embankments (Photograph 5).

Photograph 4: Looking west at the East Side EDS intake. Riprap placed in South Central Runoff Control Chute and EDS Basin. Geofabric in-place downstream of concrete cutoff wall awaiting placement of riprap following the completion of the cutoff wall installation.

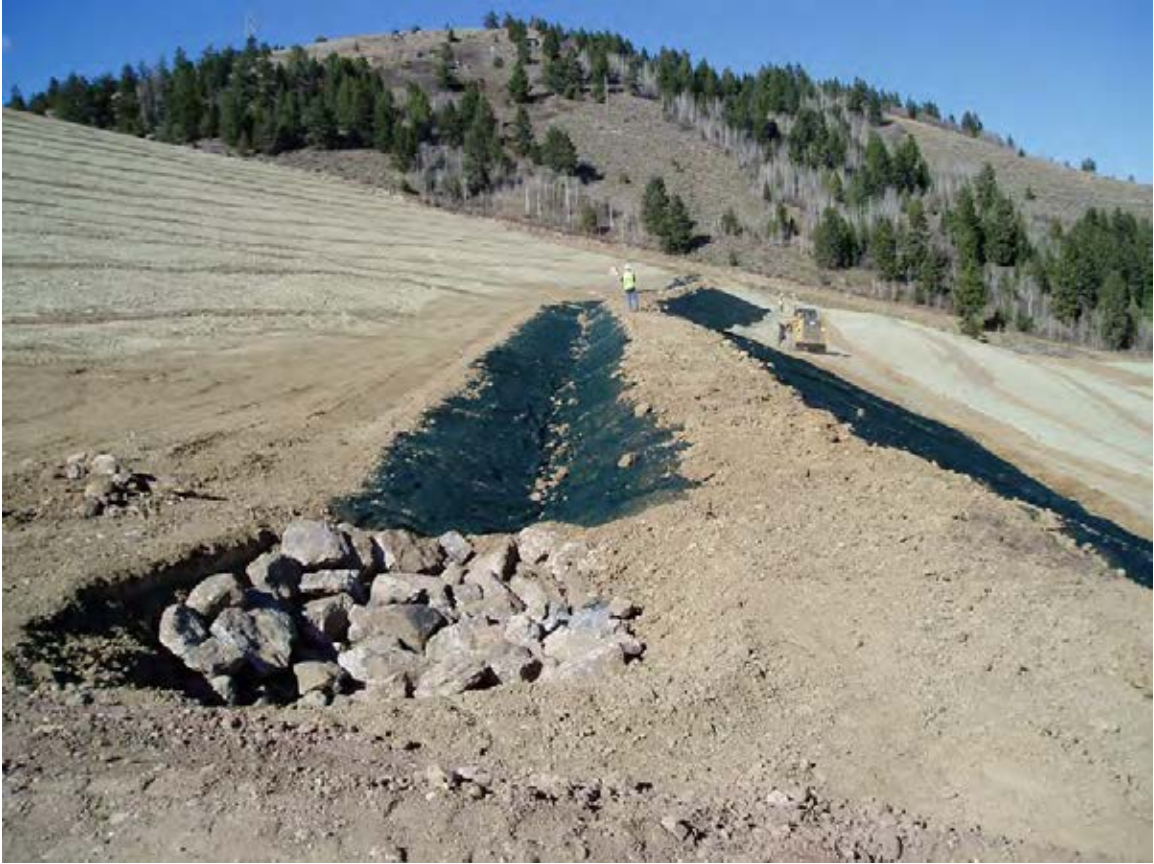
Photograph 8a: TRM lining being placed interior and exterior embankment slopes of Upper East Face Runoff Control Ditch.

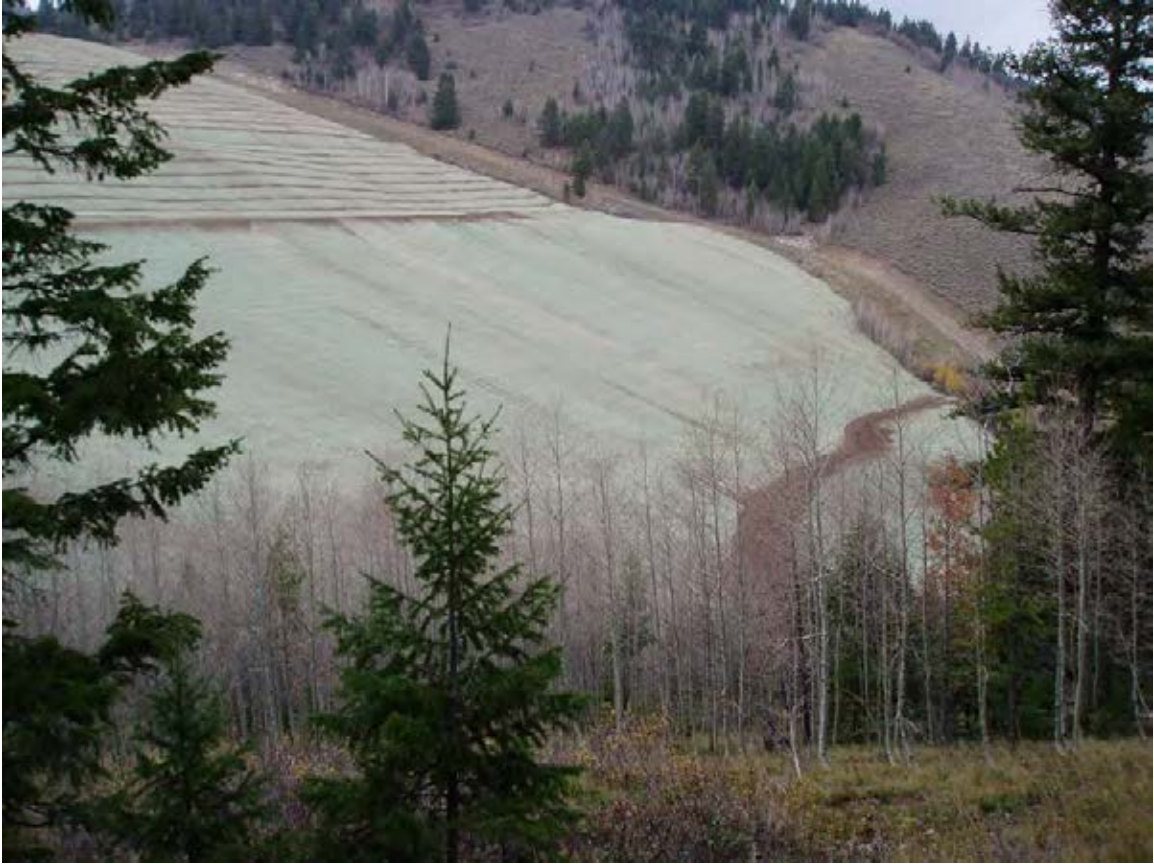
- Continue construction of Upper, Middle and Lower East Face Runoff Ditch across ES-R1/2-N and ES-R1/2-M and ES-R1/2-S. TRM lining remains to be completed (Photograph 8a and 8b).

Photograph 8b: Looking north at lower East Face ODA. Middle and Lower East Face Runoff Control Ditches have been excavated with TRM lining remaining to be installed.
